## POST INSPECTION MEMORANDUM

**Operator Inspected:**  
Northwest Pipeline Corp (WGP)

**Unit Inspected:** Sumas District

**Inspection Type:** I01 - Unit Inspection, I07 – IMP Field Verification & Follow-up, and I08 - OQ Field Verification

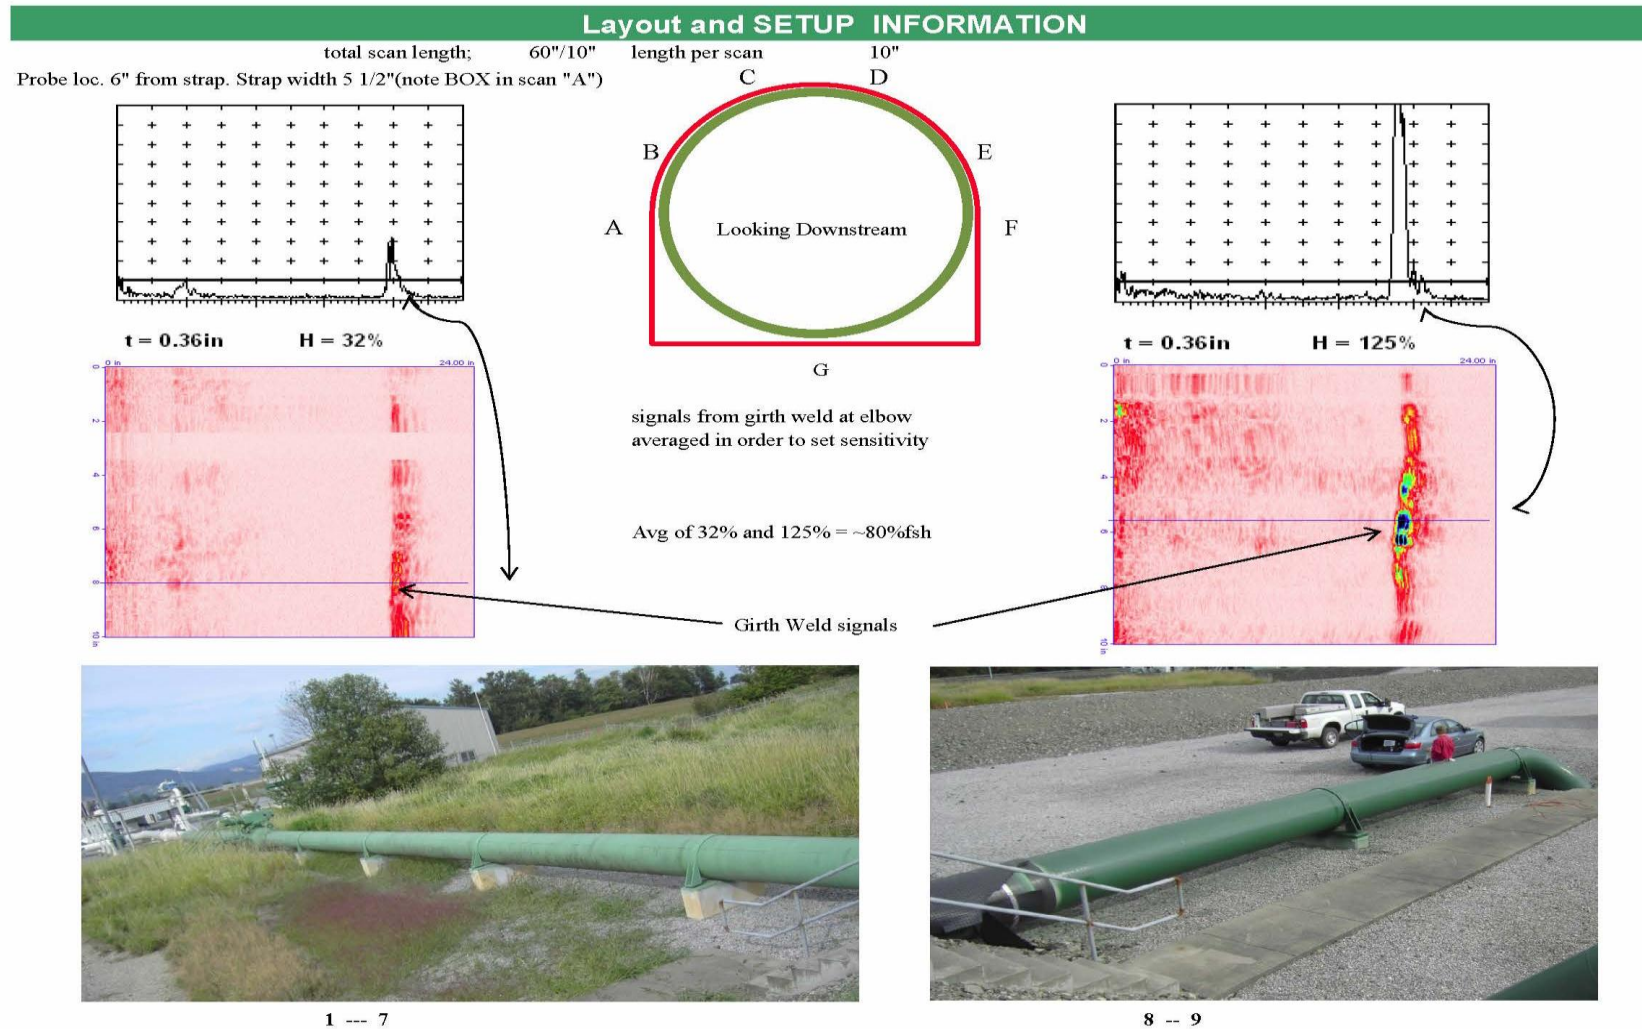
## Exhibit “A”

- B. November 2009 – NDT was completed on the 30-inch incoming line supports and straps to the Sumas Compressor Station yard. The pipe was evaluated for possible corrosion cells between the metal plate on the concrete support and the pipeline. There is no dielectric material placed between the pipeline and the supports. Short Range Guided Waves was used to evaluate 0.500" pipe wall at ten locations. The south support was of interest because it included a girth weld south of pipe strap #9 in the guided wave data. See **Exhibit "A"** (below) from Coast Wave ISONIC Investigation report for support and girth weld image. All locations were found acceptable with minimal corrosion. No additional evaluation or remediation is scheduled for this section of pipe.

Coast Wave ISONIC Investigation, NDT was completed on the 30-inch incoming line supports and straps to the Sumas Compressor Station yard. The south support was of interest because it included a girth weld south of pipe strap #9 in the guided wave data. No additional evaluation or remediation is scheduled for this section of pipe. (Wave date on right is zone “G” and left is zone “E”)
